# Manhole Inspection Summary

Manhole # S04II2012MH

**Location** Address: **3119 BONNIE RD** Cross Street: **LABYRINTH RD**

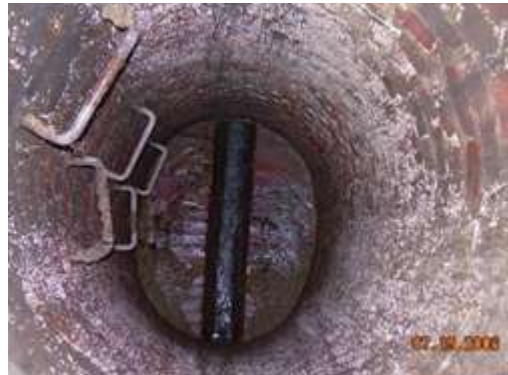
Top View

Adjustment and Corbel infiltration.  
Evidence of surcharge - Bench debris.

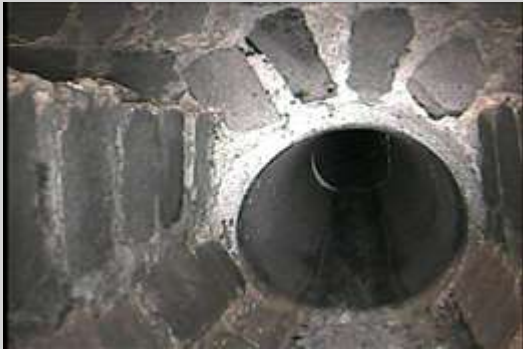
### 8 in. Circular Gravity Sewer Pipe Out @ 12 O'Clock

Pipe Material: **Clay** ☐ Pipe Lined

Invert Depth: **11.04** (ft.) Flow Characteristics: **Fast**

Infiltration: **None** Pipe Seal Cond: **Unknown**

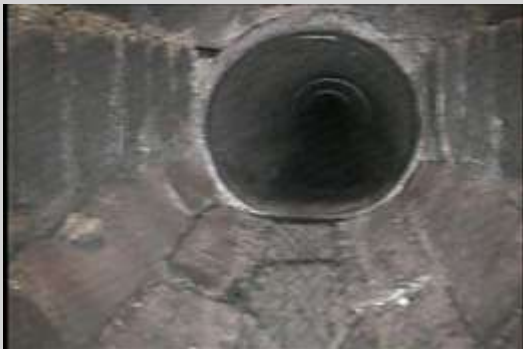
### 8 in. Circular Gravity Sewer Pipe In @ 6 O'Clock

Pipe Material: **Clay** ☐ Pipe Lined

Invert Depth: **10.74** (ft.) Flow Characteristics: **Slow**

Infiltration: **Evidence** Pipe Seal Cond: **Cracked**
